Investigation of the Column Capital Volute Failure at the
Jefferson Memorial, Washington, D.C.

Elaine S. McGee

Open-File Report 96-518

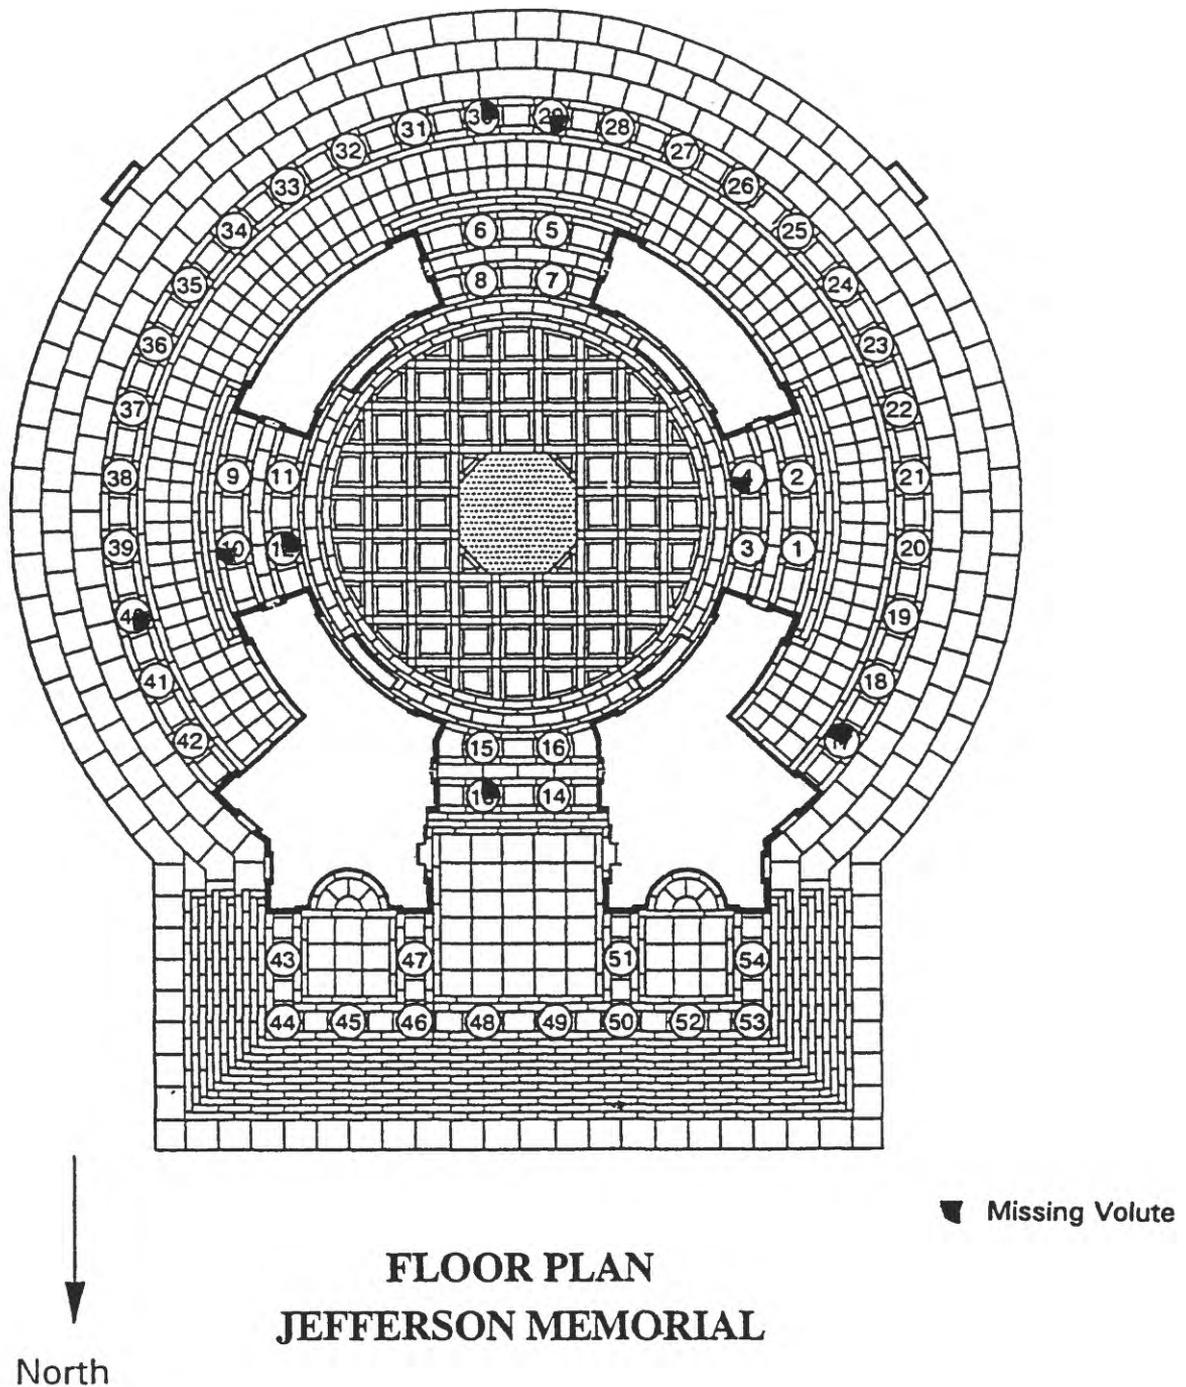
In all, there are eight fractured volutes that are distributed around the memorial as shown in Fig. 1. The fracture planes of the pieces that were removed are similar to the fracture plane of the volute pieces that remain on the column capitals. Therefore, there was no preferential parting along the fracture planes that might have left a plane of inclusions on one side but not on the other. Of the eight pieces that were removed, only one (29D) has a significant concentration of mica inclusions on the fracture plane. One of the fractured volutes (13A) was previously repaired; it has holes from pins (the pin stubs are in the column capital) and dried fragments of an adhesive material on the fracture surface. All of the fracture surfaces have accumulated dirt and several have organic growth (like algae) which indicate that the crack was open for a long time before the piece was removed. Portions of many of the fracture surfaces have a blocky, stepped appearance suggesting that slight, long-term sliding movements have occurred along the fracture plane.

Fig. 1 Plan of Jefferson Memorial, showing column numbering and missing volutes designated by a blackened quadrant where the missing volute occurs.

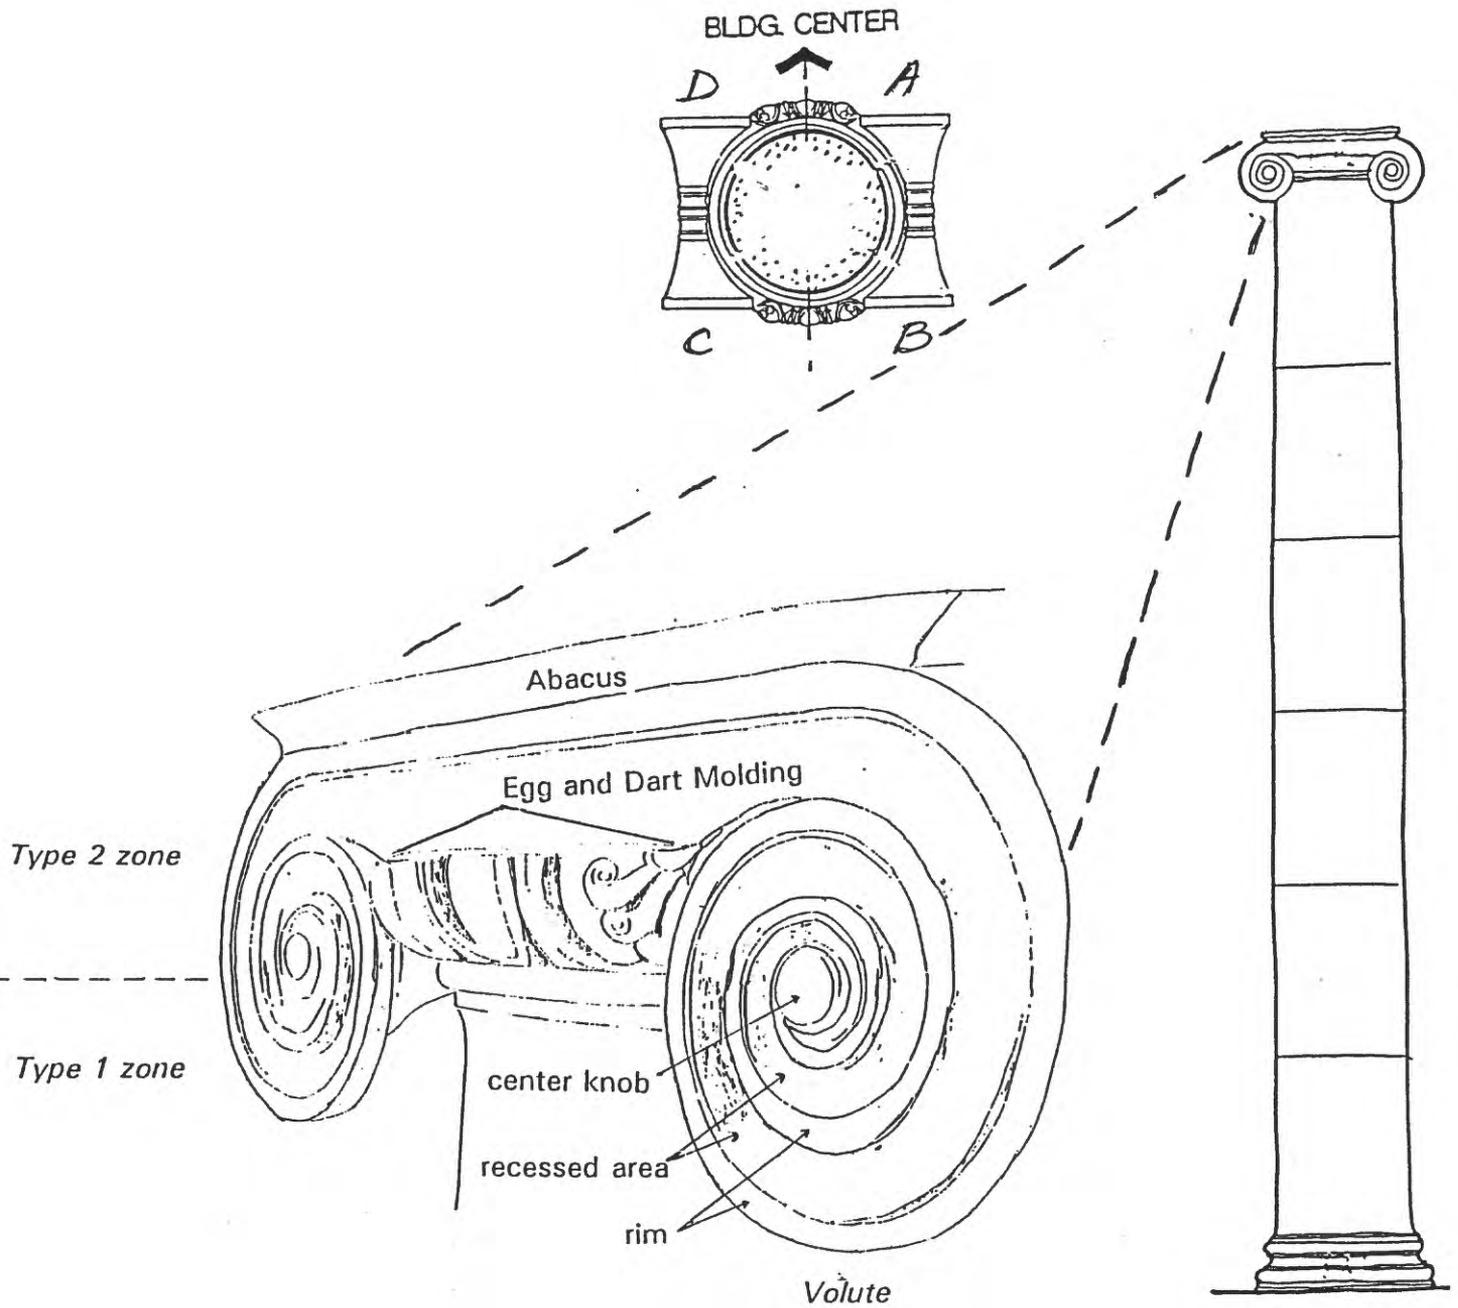
A number of cracks, with varied characteristics, were found during the examination of the column capitals. Cracks were placed in one of three categories (Type 1, 2 or 3) to reflect their similarity with the fracture plane location in the volutes that failed (McGee and Woodruff, 1993). Crack types 1 and 2 are of greatest relevance to understanding the volute failure at the memorial. Both types indicate fine lines or linear openings in the stone; type 1 occur in the lower half of the volute and type 2 occur in the upper half of the volute, where the stone is more massive (Fig. 2). A summary of the type 1 and 2 cracks identified at all the column capitals is given in Table 2.

Fig. 2 Sketch of column and column capital at Jefferson Memorial

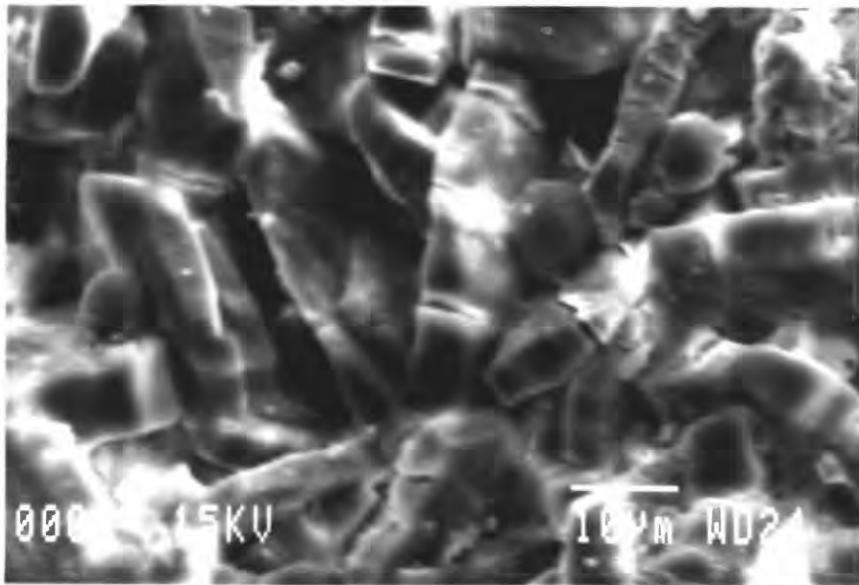
Fig. B-2. Scanning electron micrograph of elongate gypsum crystals that form a network on the marble surface. The openings between the crystals trap dirt and pollutant particles (smooth round spheres) which make the crust appear black.

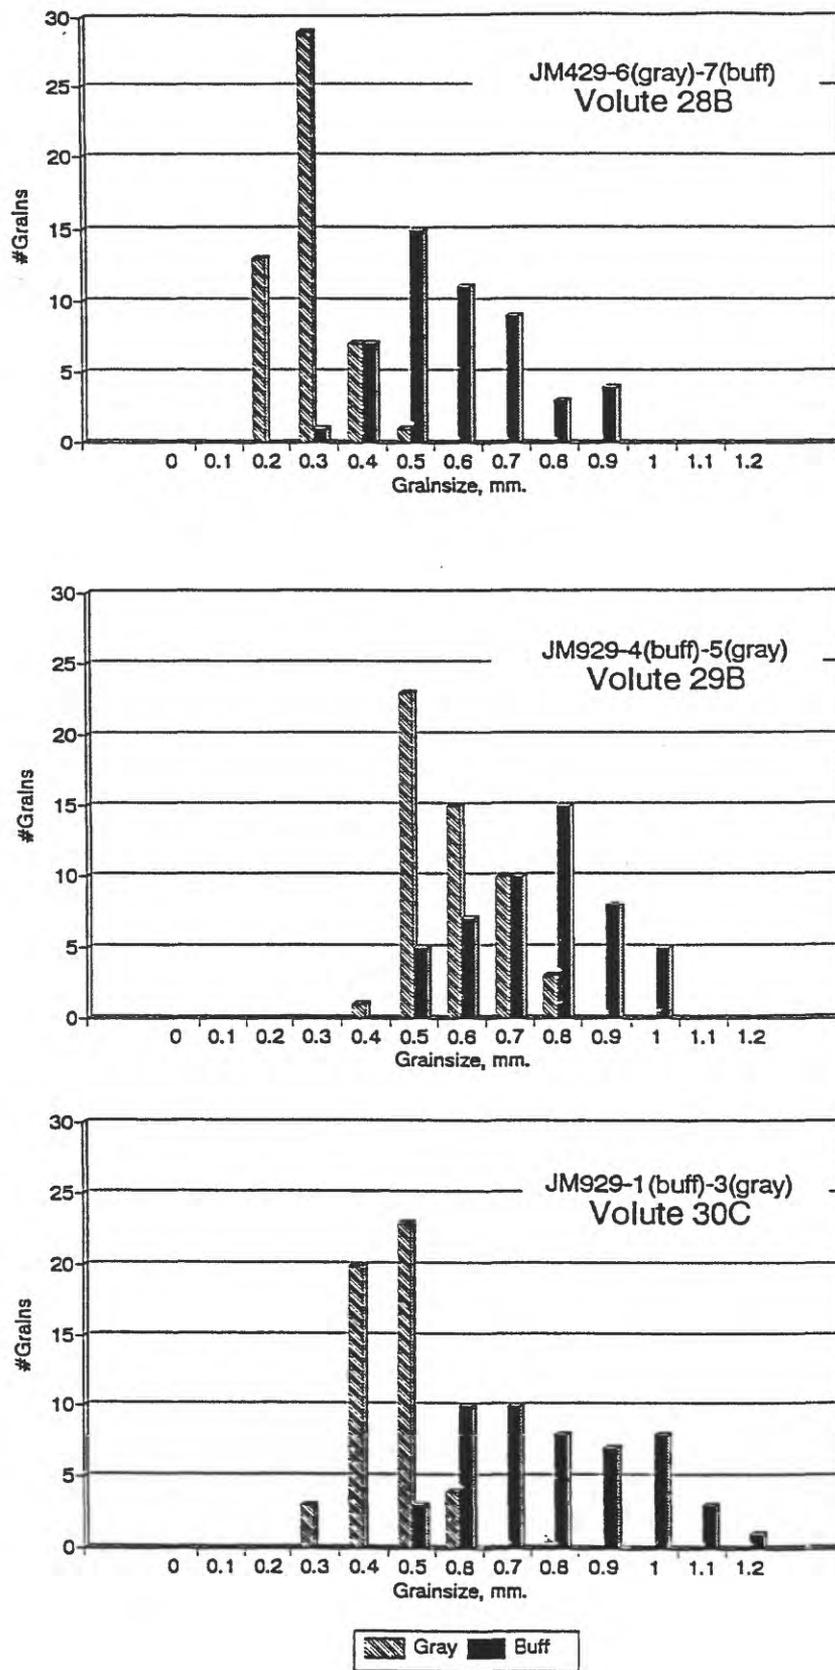
Fig. C-2 Grain size distributions for buff and gray bands from columns 28, 29, and 30.
